# Property Inspection Report

**900 Sunset Creek Ln. Pleasanton, CA.**

**Date of Inspection:**

11/02/2018

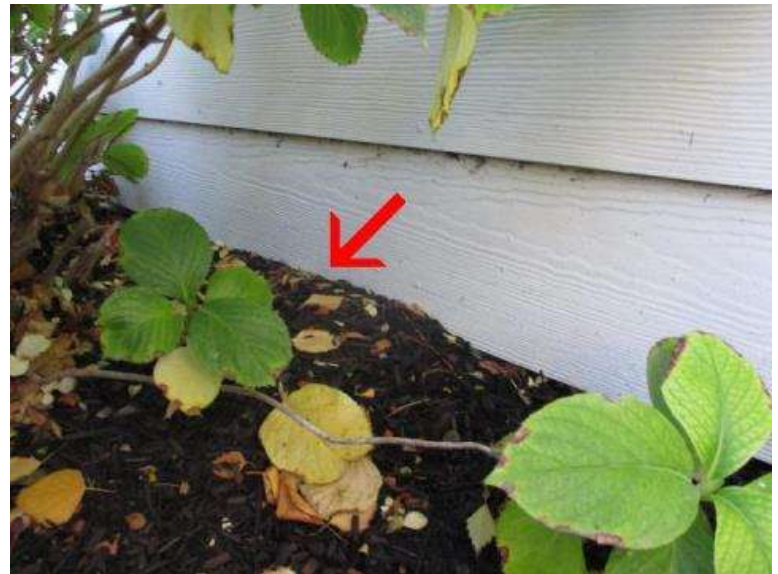
### **PHOTO 1:**

The drainage of the site is serviceable with the proper slope away from the foundation. [The soil level is too high at the foundation at the rear](#) - see PHOTO 1 for example. [Plants are touching the house](#). Surface drains are noted (not tested), underground pipes cannot be judged. [There is a missing drain cover to the subsurface drain pipe at the rear](#) - see PHOTO 2.

**SOIL LEVEL TOO HIGH:** Sometimes referred to as a "faulty grade", this is a condition where the exterior soil level is above the top of the concrete or masonry foundation. A faulty grade can allow moisture penetration, leading to decay and termite infestation. The standard in new construction is for the top of the foundation to be at least 8 inches above the soil level. Removal of soil adjacent to the foundation can eliminate a faulty grade condition, but it may also direct surface water toward the foundation. A concrete curb outside the foundation to act as a moisture barrier; or a low concrete or wood retaining wall could be installed to hold soil away from the foundation. A qualified contractor should be consulted as to the appropriate repair method. Recommend referring to the termite report for any possible moisture related damage that may be present at these areas.

**GENERAL INFO:** In general the soil and other surfaces near a building should slope away from the foundation to prevent water entry beneath the building. Excessive water may cause foundation movement, concrete deterioration and/or other damage. Flower beds and other landscaping items close to the foundation may trap or induce moisture in these areas.

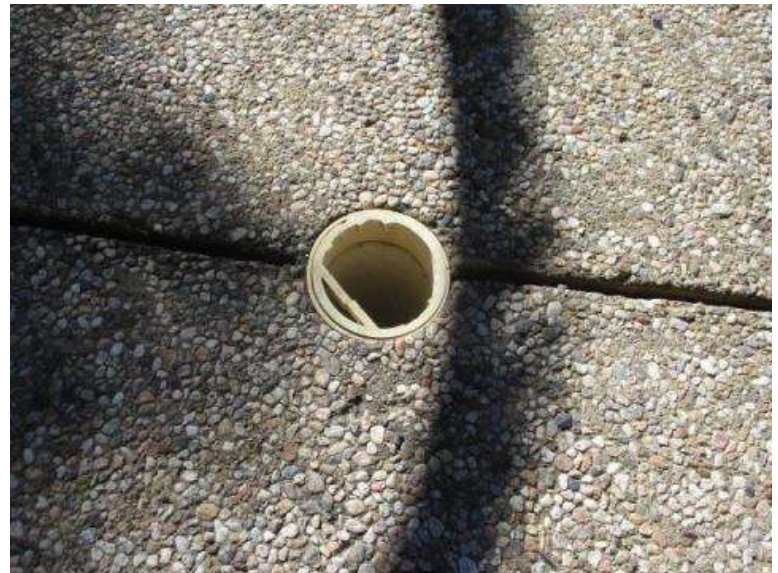
**PHOTO 2:**

A broken/missing drain cover can become a trip hazard and can allow unwanted pest and/or debris to enter and possibly block the drain lines. It would be beneficial to install a new drain cover.

Recommend having the drains tested for proper drainage now and on a regular basis thereafter as part of general property maintenance.

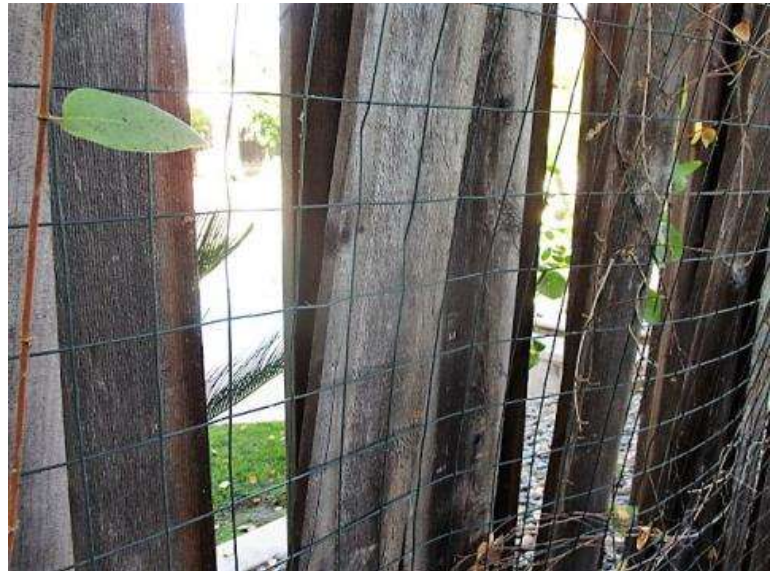
**PHOTO 1:**

The fence is serviceable. [There are loose posts noted at the left and there are loose boards at the left and right that are creating gaps in the fence](#) - see PHOTO 1 for example.

Recommend replacing or securing the loose posts where needed to help maintain the integrity of the fence and to guard against displacement during windy conditions.

Recommend securing the loose boards where needed to help prevent unsupervised children from accessing the pool which can be a hazardous condition.

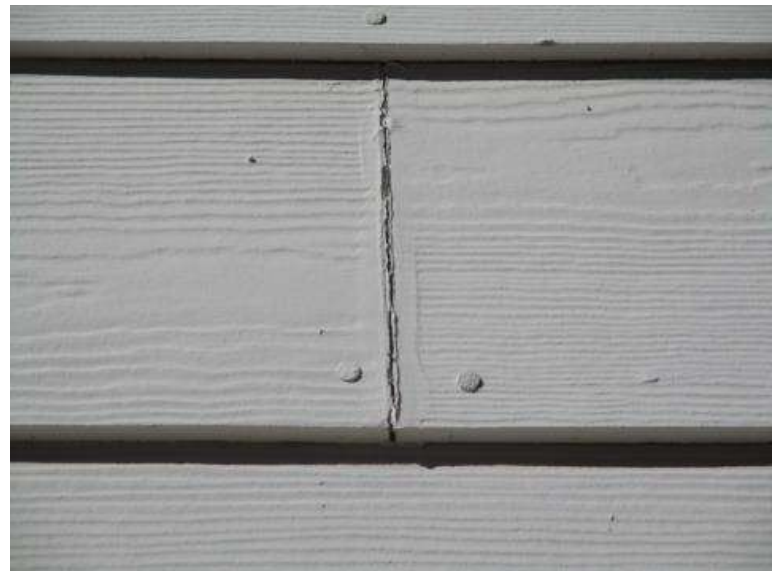
**Photo 1:**

The exterior walls are in serviceable condition. [The butt ends of the siding are separating at limited locations and in need of re-caulking](#) - see PHOTO 1 for example.

Butt ends of the wood siding should be examine and caulked on a regular basis to help alleviate unwanted water penetration. Recommend caulking butt ends of the wood siding where needed.

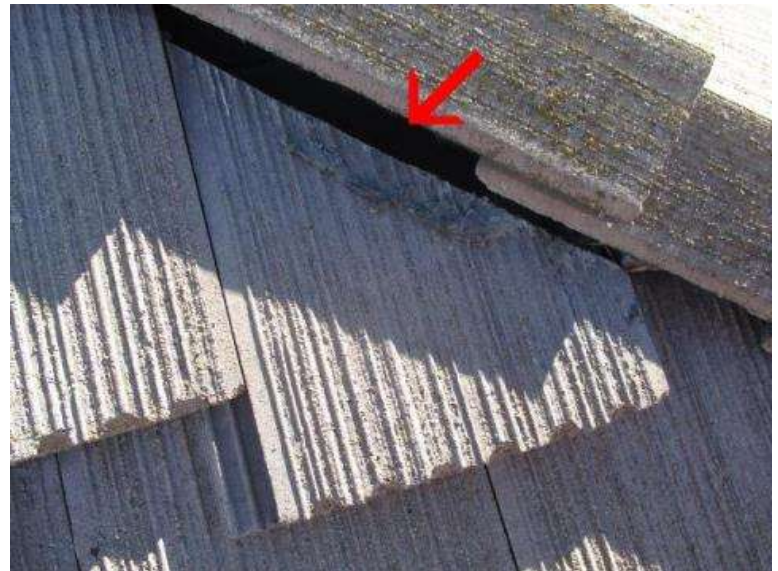
**PHOTO 1:**

The roof appears to be in serviceable condition and within its useful service life. There are two cracked tiles upon the roof surface and there are no broken tiles at this time. There is a migrating tile at the upper left hip - see PHOTO 1. There are signs of pest entry at the upper middle hip transition - see PHOTO 2.

**MIGRATING TILES:** At roof to wall transitions, an "L" type metal flashing is typically installed under or over the tiles. Installing nails through these tiles would create holes in the underlying flashing. Therefore, roofing contractors typically adhere these tiles in place. The tiles installed under the hips and roof top penetration flashings are also typically installed in this fashion. The adhesive generally lasts approximately five plus years thereby requiring periodic re-application. Recommend having a roofing contractor re-install, adhere or mechanically fasten all tiles as necessary.

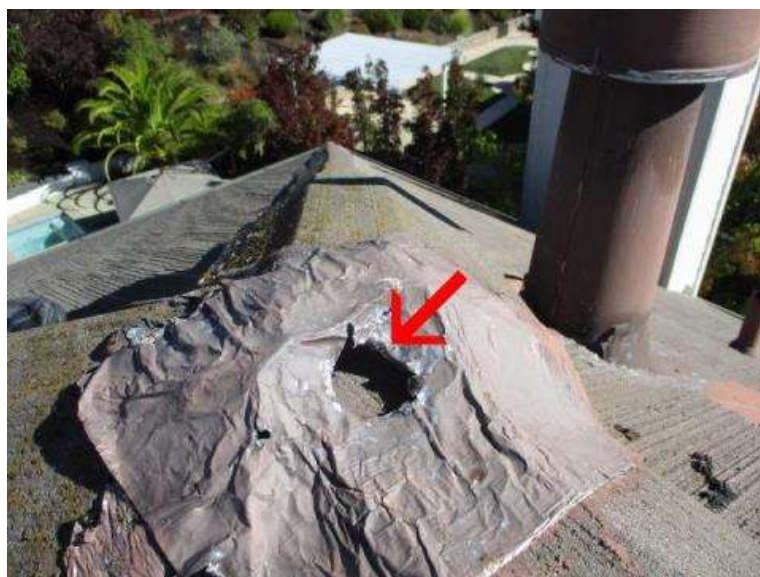
**PHOTO 2:**

It appears that vermin activity has created a hole in the transition flashing. The hole can become overwhelmed with water and a source for moisture influence under the roof. Recommend having a licensed roofing contractor repair the flashing where necessary. Although the affected flashings can be repaired, once an animal activity begins, it is generally difficult to deter. It is minimally recommended that animal access to the roof be restricted, if possible.

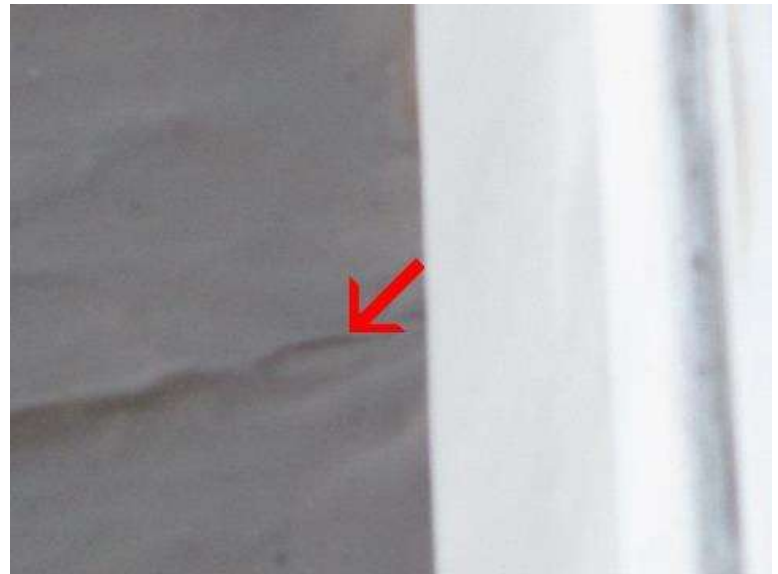
**PHOTO 1:**

There are splits developing in the lead roof to wall transition at the lower rear - see PHOTO 1 The sealant where a plumbing vent pipe penetrates the flashing at the rear is deteriorated and can allow water incursion - see PHOTO 2.

Recommend sealing the splits in the roof to wall flashings to help prevent water from accessing under the roof. This work should be performed by a licensed contractor.

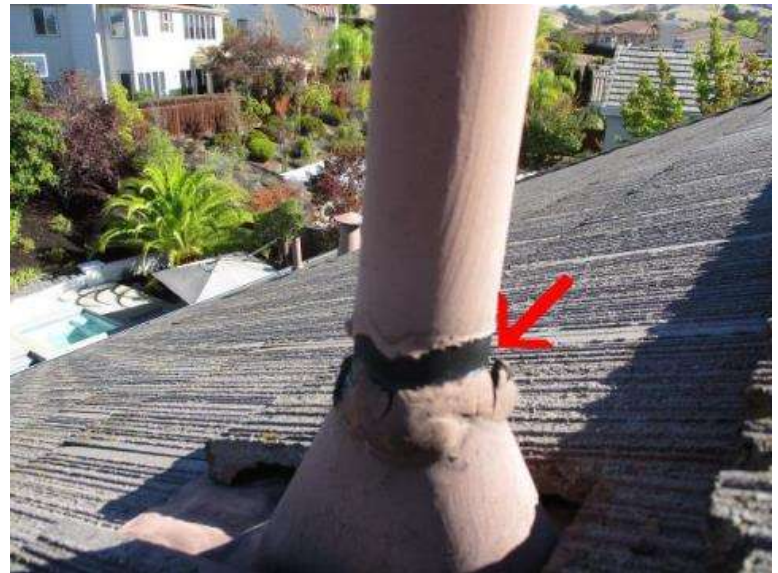
**PHOTO 2:**

**SEPARATIONS:** Exposure to heat and the normal expansion and contraction of metal may cause separations at metal flashings. All flashings should be checked annually and secured and/or sealed with mastic material or similar as necessary to prevent rain water entry. Mastic is the general name for a thick roof patching compound or cement. It is considered to be a temporary method to seal connections. Mastic dries out and cracks, typically requiring a new application every 2 - 4 years. Recommend having a licensed roofing contractor seal all areas in need promptly to help avoid water incursion.

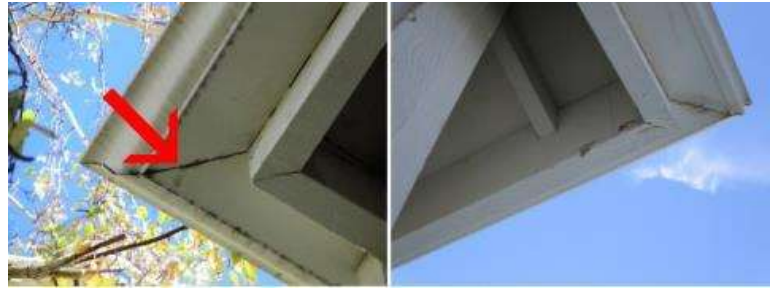
**PHOTO 1:**

The gutters and downspouts appear to be in serviceable condition. [Two gutters joints are leaking at the rear](#) - see PHOTO 1 for example. [There is a minor amount of debris inside the gutters and there is excessive debris in the gutters at the left rear](#) - see PHOTO 2. Subsurface drains have not been tested.

**RUST CORROSION/LEAKS:** Rust forms inside steel gutters as they age and rust spots or holes eventually appear on the bottoms. This typically indicates that the gutters will soon need replacement. Coating or painting the gutter interior can reduce rusting. Holes can be patched with fiberglass mesh tape and asphalt emulsion. It is generally best to replace old gutters when a new roof surface is installed. Gutter joints and other connections should be checked regularly in rainy weather for leakage and caulked or repaired as needed. Recommend having the appropriate professional repair the leaking gutters where needed.

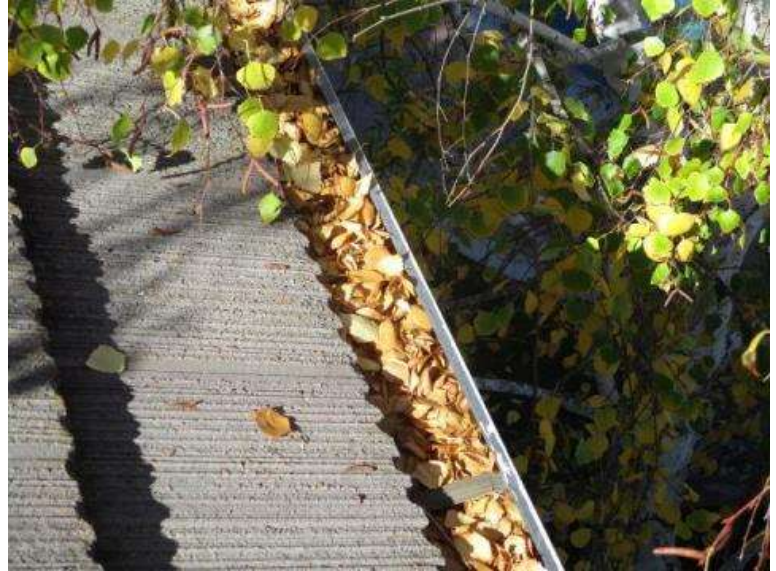
**PHOTO 2:**

**ROOF MAINTENANCE:** Roof surfaces, rain gutters, downspouts and subsurface drain lines should be checked regularly. Leaves and other debris should be removed as needed. Gutter corner joints and connections may need periodic caulking or sealing. Screens can be put at the downspout-gutter connections or dome shaped screens over drain openings to keep debris from blocking the downspout. These should be examined several times a year for debris blockage. To check for adequate drainage, walk around the building during or shortly after a heavy rain and observe the adequacy of the roof and area drainage systems. Recommend having the gutters cleaned now and regularly as part of general maintenance.

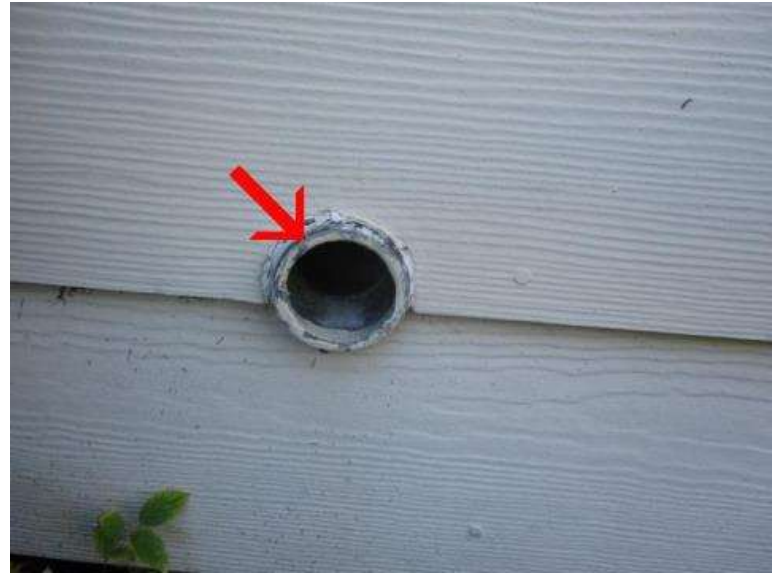
**PHOTO 1:**

The visible portions of the waste lines appear to be in serviceable condition. There were no visible leaks at this time. Not all drain pipes are visible to inspection. [There is an open waste line at the rear from the kitchen drain](#) - see PHOTO 1.

**OPEN WASTE:** Open waste lines may allow methane gas (a possible hazardous condition) or other unwanted odors to escape the drain line. All horizontal drain waste piping is required to be capped to alleviate this condition. Recommend having a licensed plumber seal the end of the waste line as necessary.

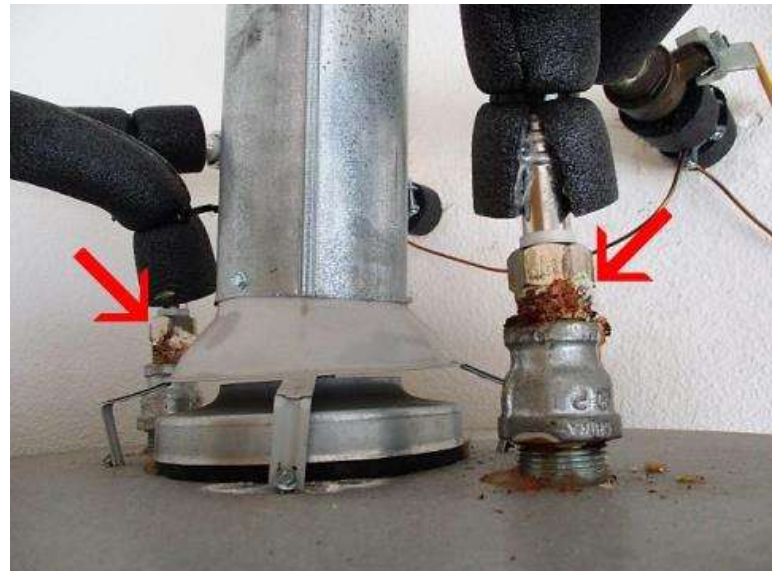
**PHOTO 1:**

There was one installed although it is not in the scope of this inspection to test it. [There is corrosion on the pipes](#) - see PHOTO 1.

**CORROSION:** Anytime there is corrosion on any piping it is a sign that it has been moist in the past and MAY begin to leak in the future with further deterioration. Recommend periodic inspection to help determine any recent leakage which may occur and prompt repair as necessary. It may be necessary to repair or replace the pipe in the near future.

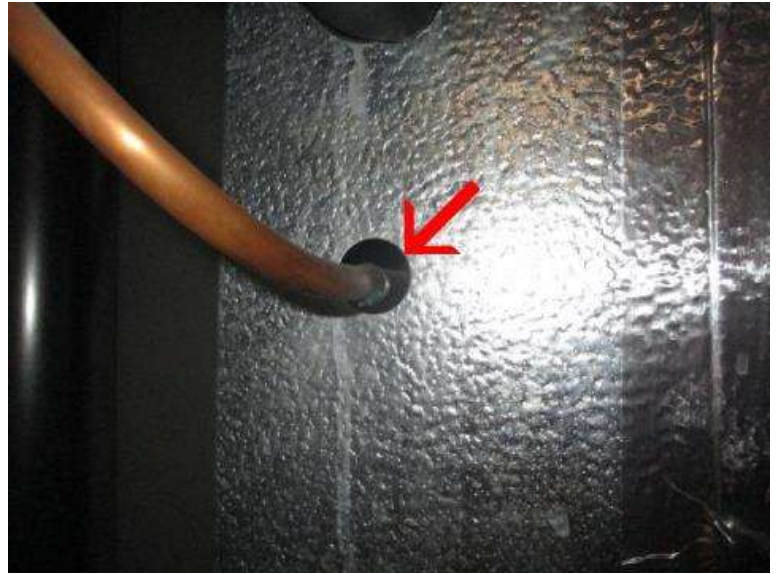
**PHOTO 1:**

Both are operational. [UNIT A: The grommet at the AC line is missing at the plenum](#) - see PHOTO 1.

**PLENUM:** Air leaks are common at the plenum as the sealing material deteriorates which can allow conditioned air to escape, reducing system efficiency. Leaks may also allow mixing of combustion air (a possible hazardous condition). Recommend sealing around the air conditioning lines as needed to alleviate the escape of conditioned air.

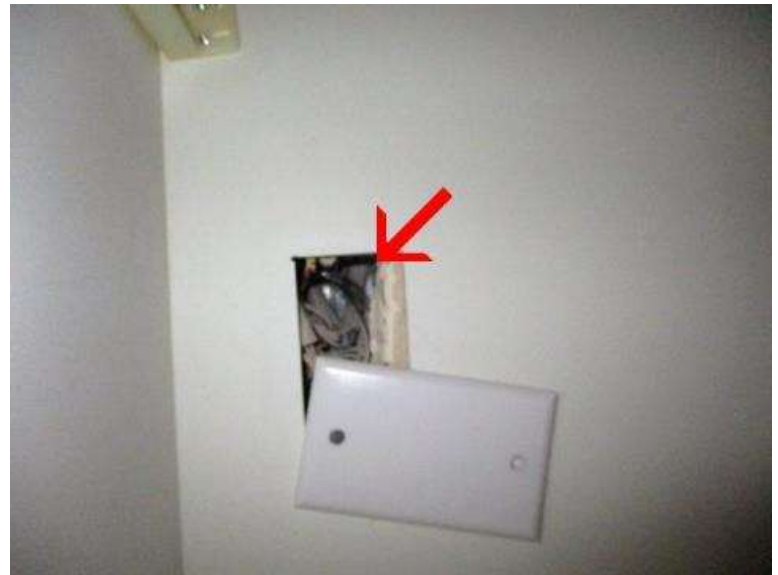
**PHOTO 1:**

MISSING COVER PLATES: Recommend having all electrical outlets covered with the appropriate cover plate to help alleviate possible shock.
