## Roof Inspection

Roof Type: **Sculptured S Concrete Tile Roof**      Approx. Age:      29 years  
 Layers:      One layer  
 Approx. Slope(s):      5:12 - 6:12

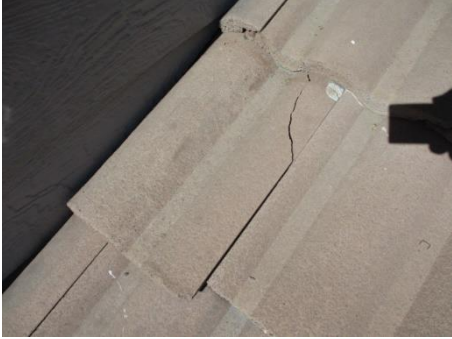
**PHOTO 1**

1. There are two broken tiles at the lower front roof elevation above the garage and one below the upper front gable. Water can permeate the tiles and access under the roof – see Photos 1 & 2.

1. Replace the broken tiles.
2. Repair all tiles with high chips. Reposition, secure and/or seal the laps at the deflected tiles.
3. Re-secure the loose rake tiles.
4. Lift/remove tiles as necessary and clean the debris from the roof.

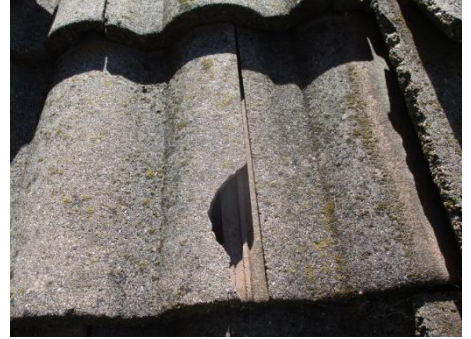
**PHOTO 3**

2. There are limited number of tiles with high chips. At the lower right; one tile and the adjacent tile are somewhat deflected off the roof. The felt paper is exposed and intact at this time. Prolonged exposure of the felt paper can cause deterioration and the development of holes in the material which will allow water leakage – see Photo 3 for example.

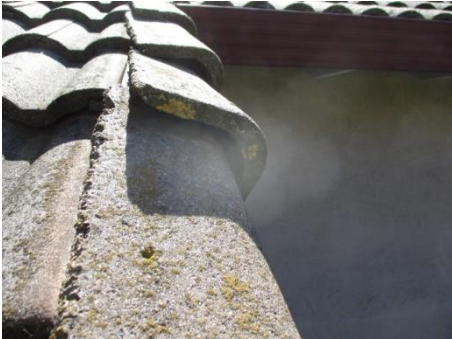
**PHOTO 4**

3. There are moderate number of loose rake tiles at various locations which is a hazardous condition to pedestrian traffic below and can allow water to access and damage the barge rafter – see Photo 4 for example.

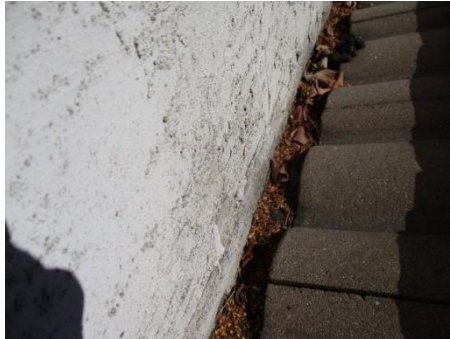
**PHOTO 5**

4. At the right-side chimney and the lower front valleys, there is moderate debris which can interfere with drainage and divert water under the roof – see Photo 5 for example.
