Roof Inspection

Roof Type: **High Profile Laminated Asphalt Composition Shingle Roof** Approx. Age: 15 years
 Layers: One layer
 Approx. Slope(s): 6:12

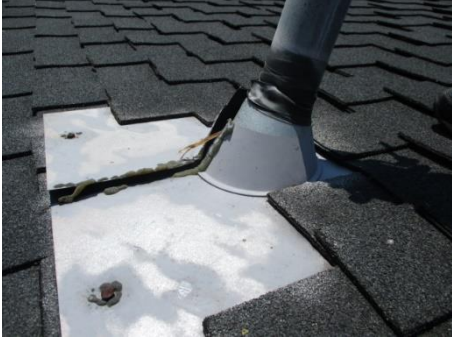
PHOTO 1

1. The main electrical mast flashing has deteriorated sealant and a large void at the split which can allow water incursion and damage to the eave – see Photo 1.
2. There is a cable lying on the roof and is beginning to damage a ridge shingle and lift a field shingle – see Photo 2.
3. At the left rear, the drip edge flashing is loose – see Photo 3.
4. There is a satellite dish without sealant at the bolts. Water can seep into the bolt penetrations and access under the roof – see Photo 4.
5. The counter flashing at the chimney is not properly overlapping the step flashing. Water can seep behind the flashing and access under the roof – see Photo 5.
6. There are a moderate number of popping hip and ridge nails at various locations which can allow for wind uplift during high winds and water to access under the roof – see Photo 6 for example.
7. Overview of the roof – see Photo 7.

1. Secure and seal the main electrical mast.
2. Recommend having the appropriate professional remove/re-route the cable off the roof.
3. Re-secure the drip edge flashing to ensure water is properly diverted into the gutter.
4. Seal the satellite dish bracket.
5. Seal the flashing at the chimney.
6. Set and seal the nails.
